DDAS Accident Report

Report date: 31/01/2008	Accident number: 542
Accident time: 11:10	Accident Date: 09/01/2007
Where it occurred: Ar Rafiyah District, Basrah Province, Southern Iraq	Country: Iraq
Primary cause: Inadequate training (?)	Secondary cause: Field control inadequacy (?)
Class: Handling accident	Date of main report: 09/01/2007
ID original source: BOI 001 091007	Name of source: [Name removed]
Organisation: [Name removed]	
Mine/device: BLU-61A/B	Ground condition: dry/dusty
Date record created:	Date last modified: 31/01/2008
No of victims: 2	No of documents: 2

SUBJECT: BOARD OF INQUIRY REPORT

FOR [Demining group] UXO ACCIDENT IN AR RAFIYAH DISTRICT, SOUTHERN IRAQ, 09 January 2007

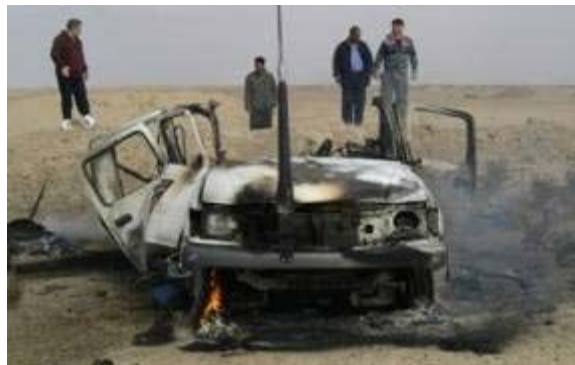
The accident is classed as a "Handling accident" because Victim No.1 lost both arms and suffered severe abdominal and chest injury. The investigator did not speculate about why Victim No.1 would have been holding the submunition, or why there should have many more in the load-bay of the pick-up. It is clear that there were submunitions in the back of the vehicle for the following reasons. The damage to the vehicle included many penetrations from

inside the load-bay outwards. The scattered munitions, some of which were weathered and aged, were all sitting on the surface. They would have tended to weather in if they had been there any time. It is also unlikely that Victim No.1 would have deliberately parked among visible munitions. There was speculation at the time that the Victims had been the deliberate targets of an Improvised explosive device. This is possible, and might explain why Victim No.1 picked up something (perhaps designed to be intriguing) and examined it, but the alternative view of his having been handling an unstable submunition fits more of the known facts.

It is worth noting that the interview with Victim No.2 did not include asking him why there were munitions in the back of the vehicle. It may well be that the answer would have been embarrassing. This observation illustrates the weakness of an internal accident investigation. The investigators noted that some things must have been the case, but did not list them in their conclusions. It is also worth noting that the investigators approached the vehicle while it was still burning without wearing any PPE. It is not unusual for accident investigators not to wear PPE, but the danger in this place was known to be real and the failure to wear PPE was at best thoughtless.

10.1 Retraining of all personnel in General Safety, specifically in dealing with Cluster Munitions, transporting of UXO, and the wearing of PPE.
